Testing of the Oztec/Rhodes Reinforcing Bar Shaker

FINAL REPORT

August 15, 2003

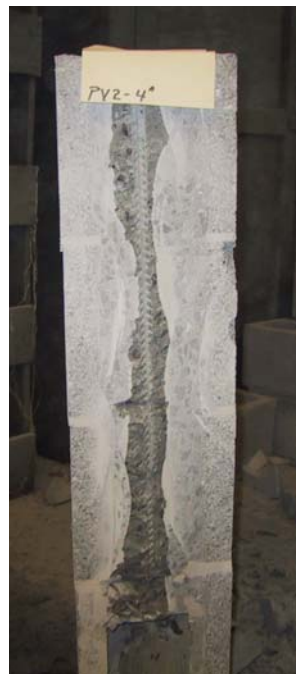
Figure 4. Wall cross-section with pencil vibrator consolidation

After the pullout testing was conducted, the walls were cut apart with a masonry saw to examine the condition of the interface between the grout and reinforcing bars and to inspect for any voids. Typical pictures from the pencil vibration wall are shown in Figures 4 and 5. Note that there are no voids, good bond between the grout and the masonry units, and the reinforcing bar indentations are clearly visible in the grout. Similar results were obtained when using the reinforcing bar vibrator. Figures 6 and 7 show the wall cross-section with a #5 bar. Figure 8 shows the wall cross-section with a #4 bar. There again are no voids, good bond between the grout and the masonry units, and the reinforcing bar indentations are clearly visible in the grout.
